# Letter to the Editor

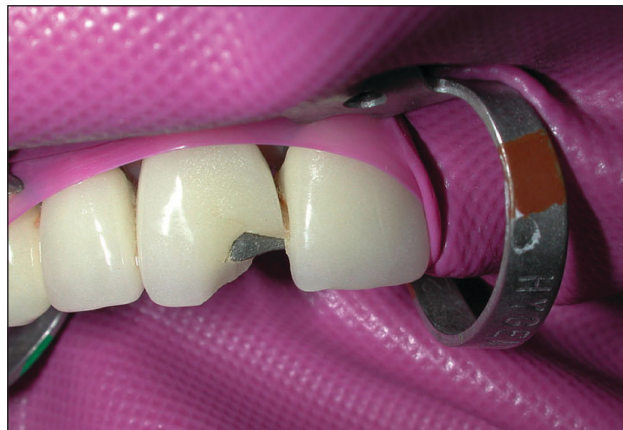
**Figure 1.** Porcelain fractured off 10 year-old bridge following trauma. Metal surface abraded with Cojet (3M ESPE, Seefeld, Germany) sand in intra-oral sandblaster.

The second omission is the absence of a reference to a method of metal-ceramic repair which I have found most useful clinically over the past decade (1). I refer to Cojet (3M ESPE, Seefeld, Germany) which is based on the well tried and tested laboratory process Rocatec (3M ESPE). This is a system which blasts the exposed metal surface with aluminium oxide-silica, with the silica becoming impregnated in the outer 10 microns of the metal surface by a tribochemical reaction. Following application of a silane, and the system's opaquer, the defect may be repaired by resin composite.

I have not carried out a structured clinical evaluation of the repairs that I have carried out other than reviewing these after one year, but have not had a failure in 15 repairs using this system. An example of such a repair is shown in *Figures 1* and *2*. Cojet may also be used to treat the metal surface in order to enable the repair to be carried out by a laboratory-made facing, which then may be bonded to the defective crown using a resin-composite luting material.

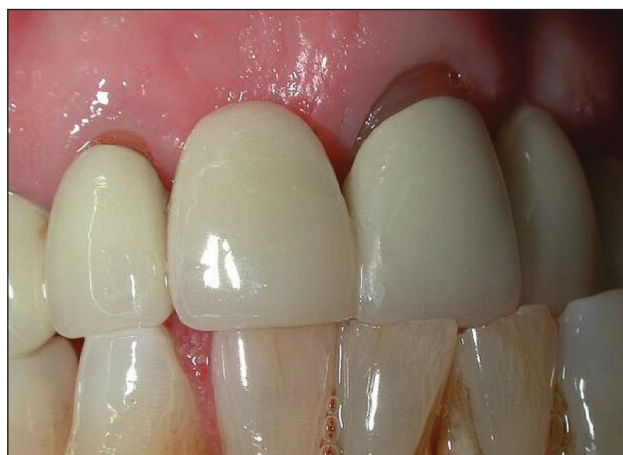
**Figure 2.** Following application of silane, opaquer, bonding resin as per manufacturers' instructions, the defect was repaired with resin composite (Z250: 3M ESPE).
