Fibre-post

# Restorative Case Report: Flexibility of Fibre-Posts

## ABSTRACT

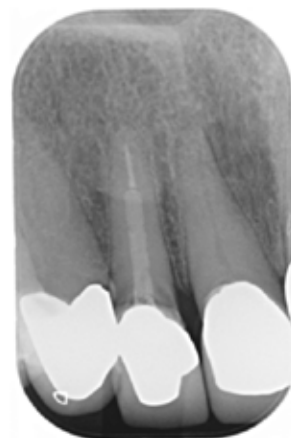
A periapical radiograph (Figure 2), showed an acceptable root-filling in the tooth and a fibre-post seating against the gutta percha with no apical pathology and good alveolar bone-levels. A radiolucent area was evident beneath the crown.

**Figure 2:** Periapical Radiograph of Upper-Right-Lateral Incisor.

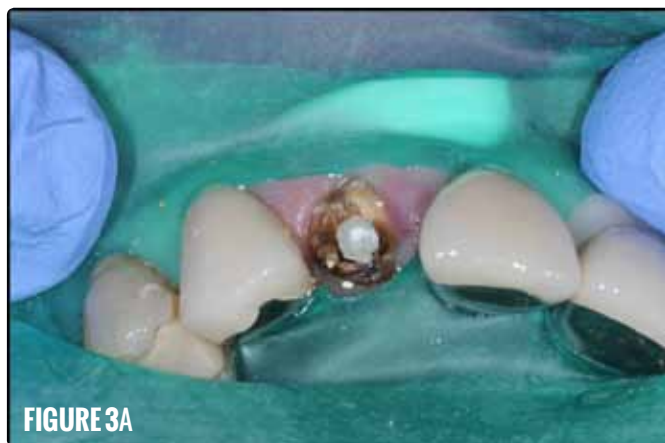
The crown was displaced easily with application of vertical force via an excavator and the composite-core was intact. Debris was evident on the neck of the tooth. Application of pressure buccally and palatally bent the intact core on the post in the equivalent direction (Figure 3).

**Figure 3:** Intact-core and buccal displacement of fibre-post on application of pressure.

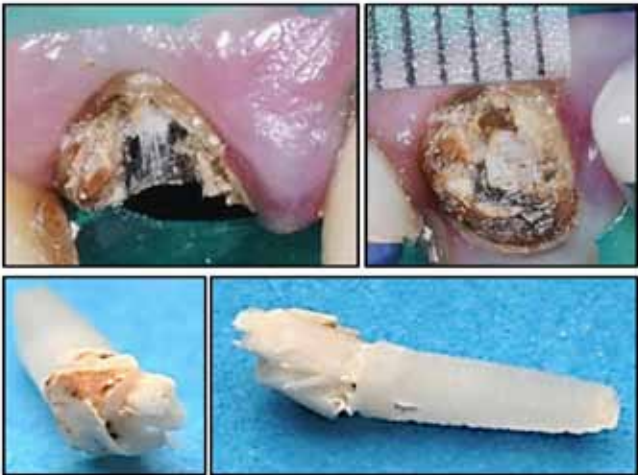
The fibre-post and core were detached, leaving the apical portion securely cemented within the root (*Figure 4*).

**Figure 4:** Apical portion of fibre-post retained in intact-root and detached coronal portion with composite-core.

Very little coronal tissue remained, with none for a ferrule. No root-fracture was evident and the tooth was of aesthetic value, receiving little occlusal loading in lateral excursion.

Treatment options were discussed (*Table 2*) and re-treatment of the tooth was undertaken, with removal of the remaining fibre-post with the aid of magnification, e.g., loupes and a microscope, and a diamond-coated ultra-sonic tip [CT4].

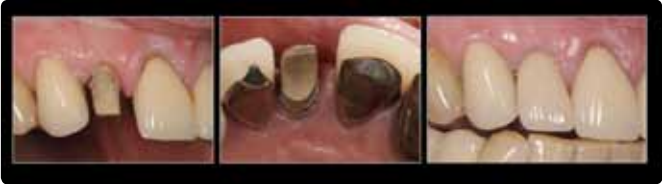
**Figure 5:** Cast-post with definitive metal ceramic crown in-situ.

The cast-post [Dentalor®60] was cemented with an adhesive cement [Panavia 21™], followed by a further silicone impression with gingival retraction-cord [Ultrapak]. A laboratory temporary-crown restored aesthetics and function in the interim and was succeeded by a metal ceramic crown (*Figure 5*).

Following discussion with this Patient, re-treatment involved the use of a cast-post and core with a metal ceramic crown, with the aim of reducing the flexure of the post. This method had provided a successful prosthesis for 18 years prior to placement of the fibre-post. The original cast-post was replaced due to loss of retention from cement failure.
